# **Final Third Five-Year Review Report**

**Luke Air Force Base, Arizona**

**July 2012**

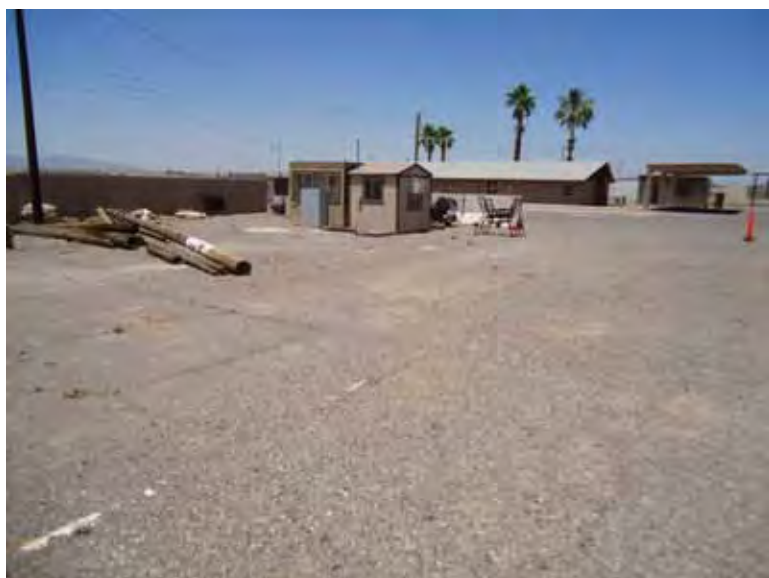
RW-02: Looking northwest at monitoring wells at RW-02

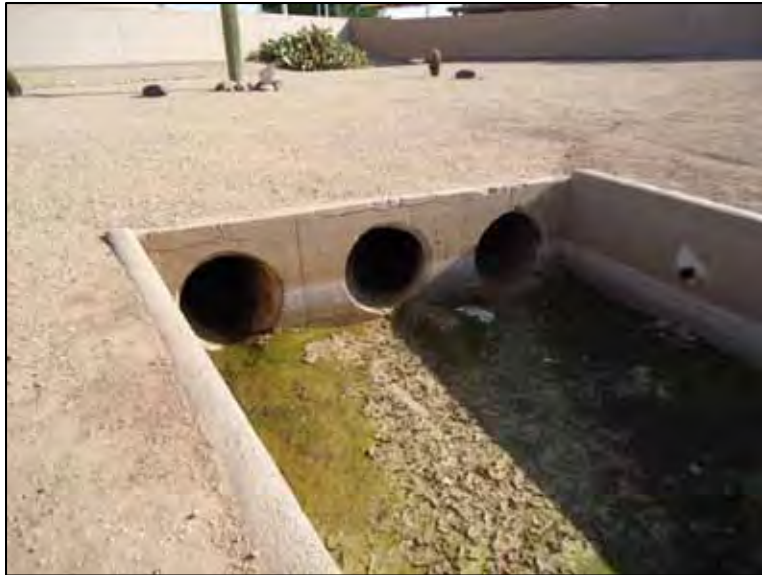
SD-20: Beginning of drainage channel, culvert on north side of Super Sabre.

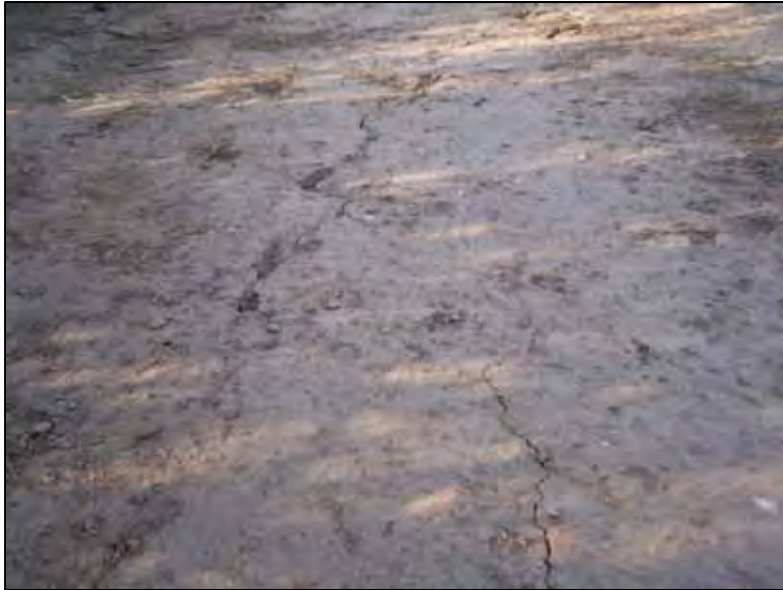
SD-20: Example of cracks  
in hardpan

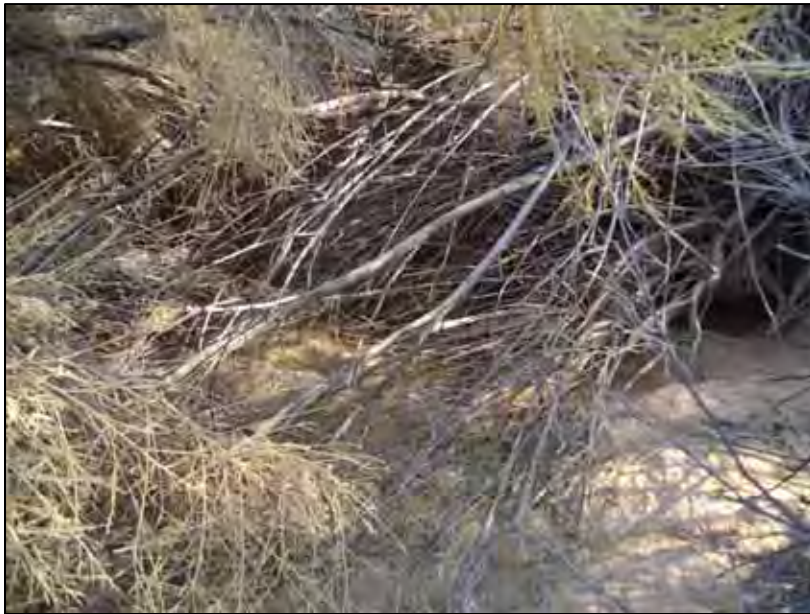
SD-20: Earth fissure  
located at south end of  
drainage channel

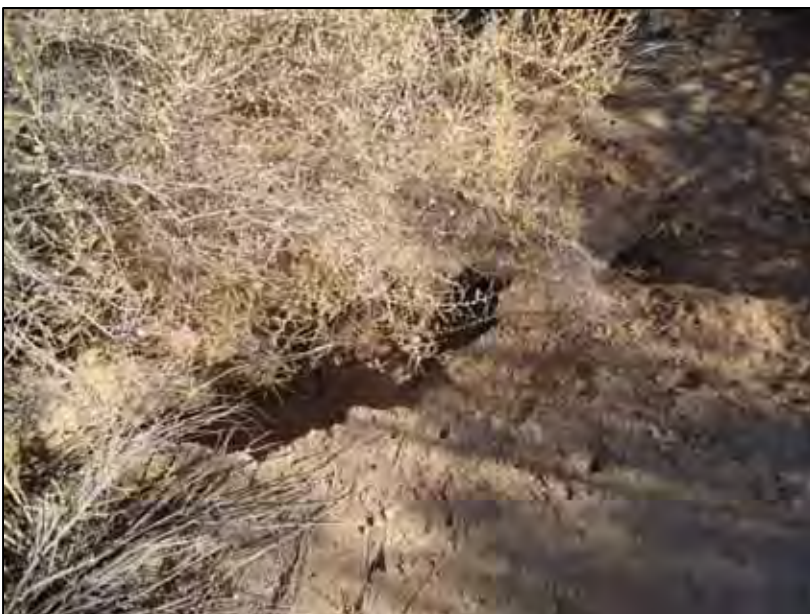
SD-20: Earth fissure  
located at south end of  
drainage channel

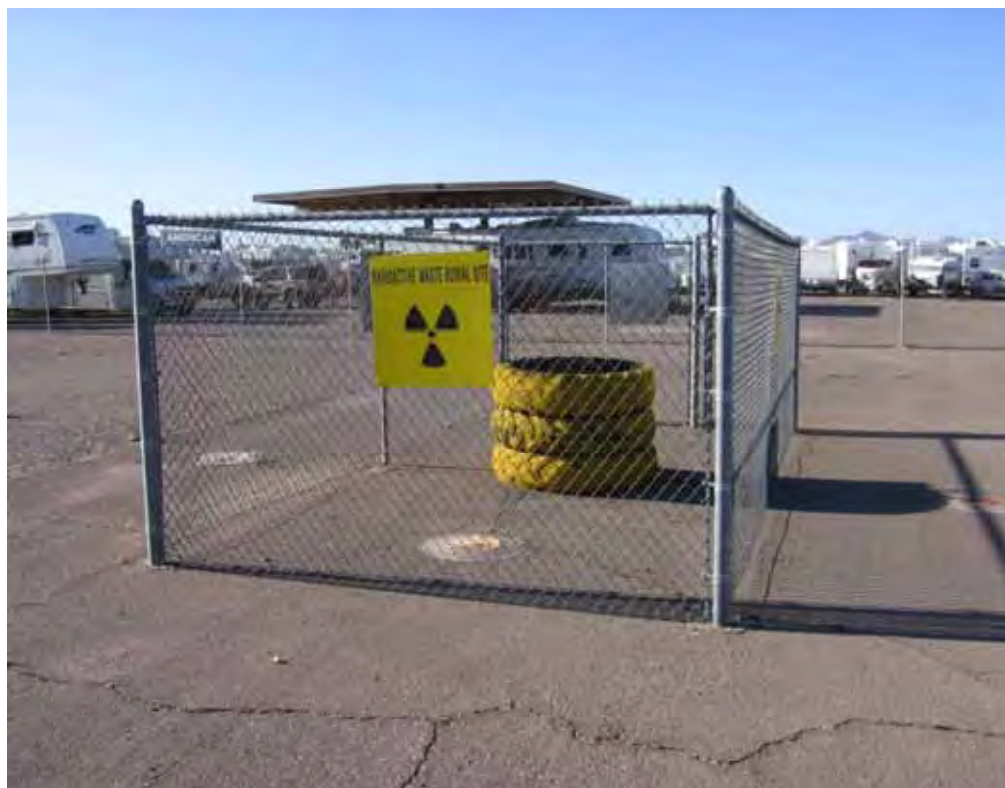
Photograph 1: Fencing and placard around radioactive burial site.

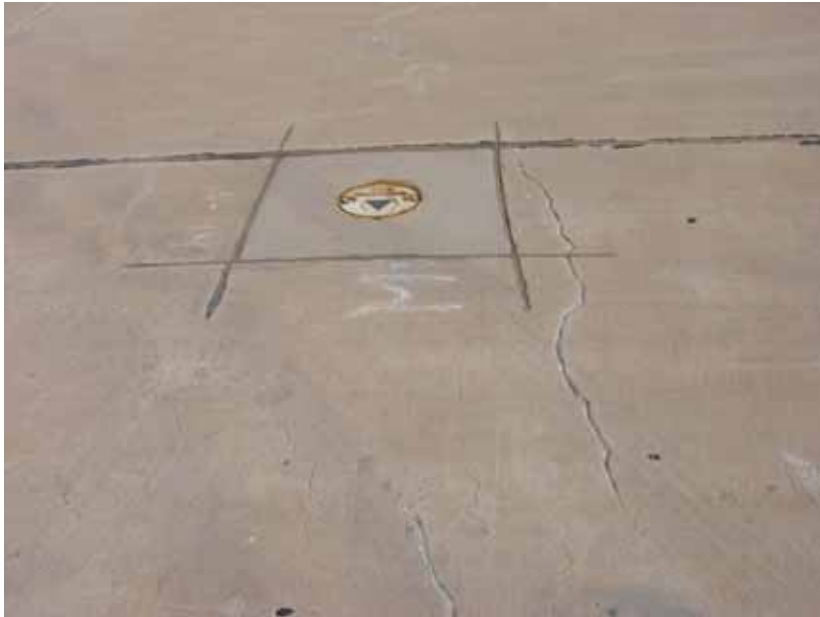
Photograph 2: January 2009 repair of concrete cuts around well completion, repairs performed by Tierra Dynamic.

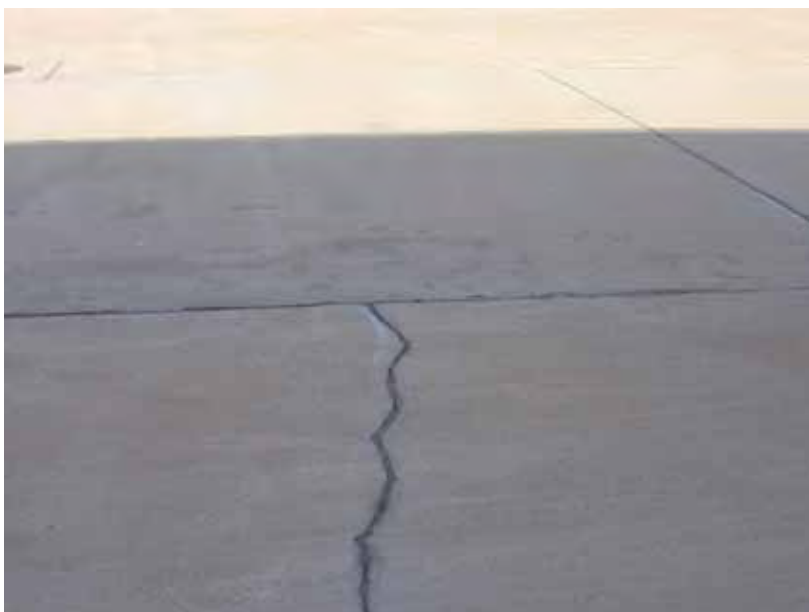
Photograph 3: Example of previous crack repair in good condition.

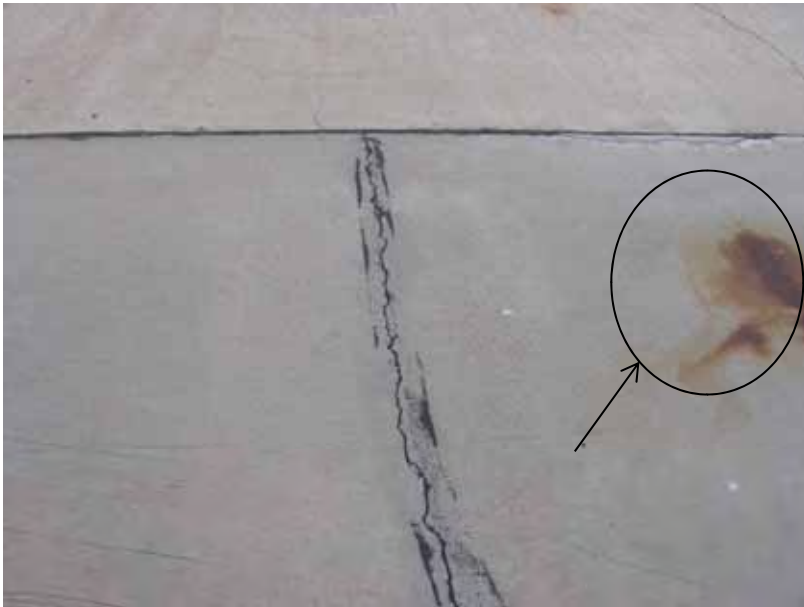
Photograph 4: A previous repair, thought to be 1<sup>st</sup> generation, in good condition.  
Small rust stain present of unknown origin.

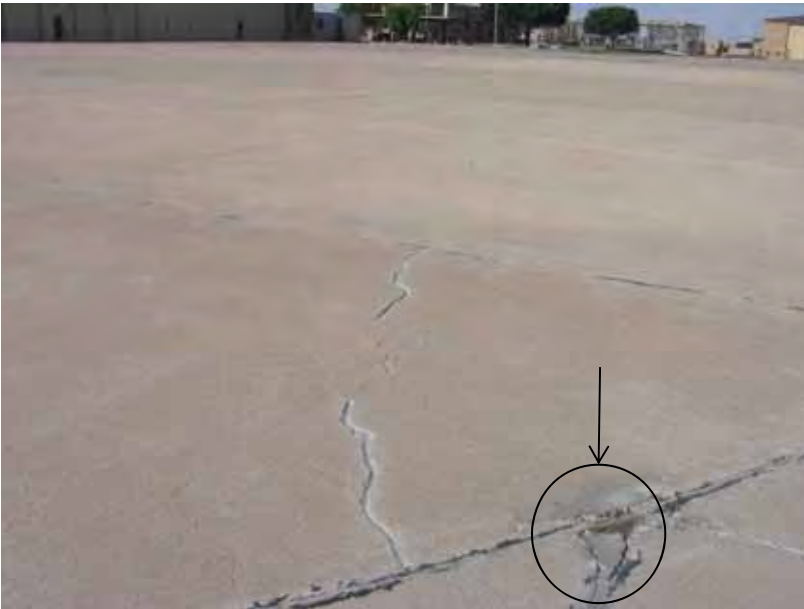
Photograph 5: A previous repair that may warrant additional repairs due to additional cracking and spalling present adjacent to the repair.

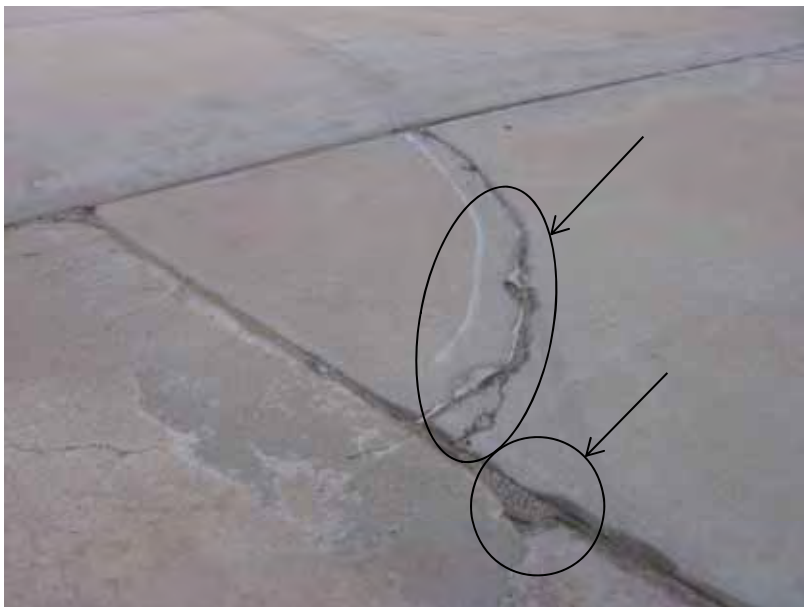
Photograph 6: A previous repair that may warrant additional repairs due to additional cracking and spalling present adjacent to the repair.

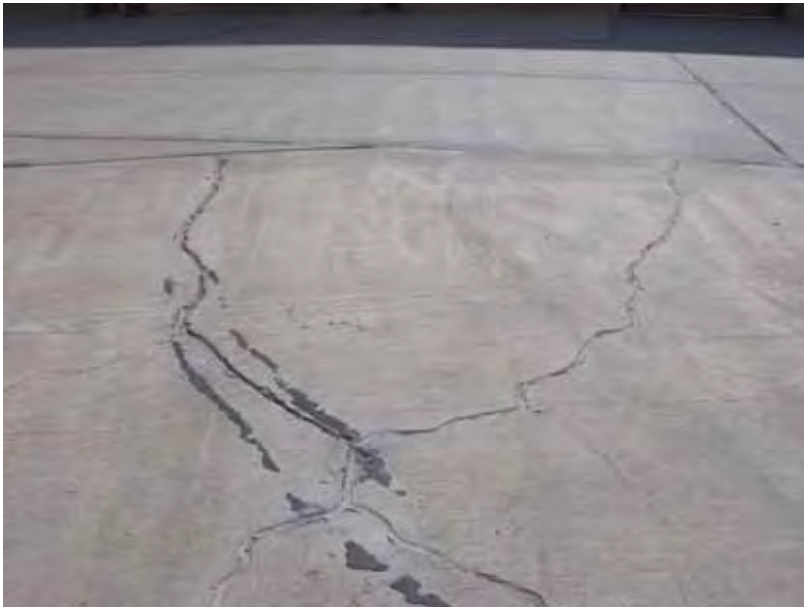
Photograph 7: A previous repair that may warrant additional repairs due to additional cracking and lack of repair material within the repair.

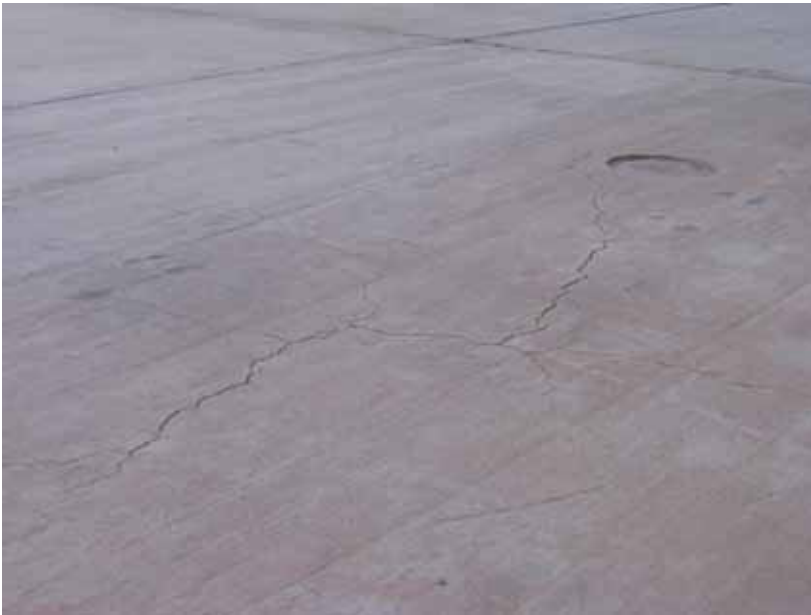
Photograph 8: Example of shallow surface cracking. Cracking with vertical or horizontal displacement are considered to penetrate the full depth of the concrete thickness.

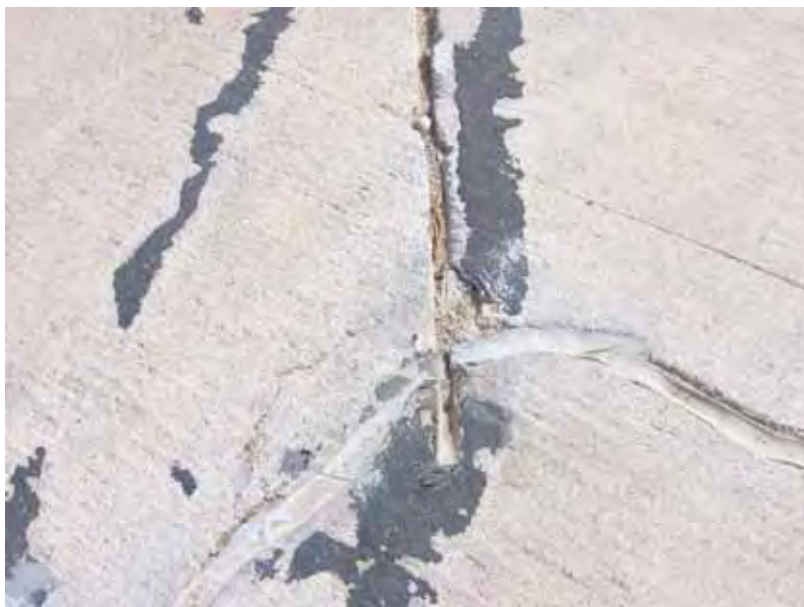
Photograph 9: A previous repair that may warrant additional repairs due to additional cracking and spalling present adjacent to the repair.

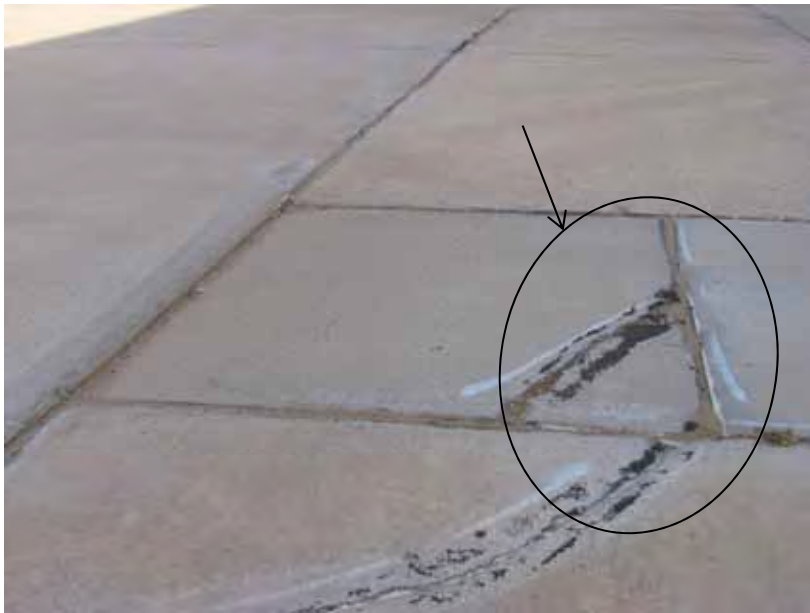
Photograph 10: A previous repair, that may warrant additional repairs due to additional cracking, the presence of spalling, and lack of repair material within the repair.

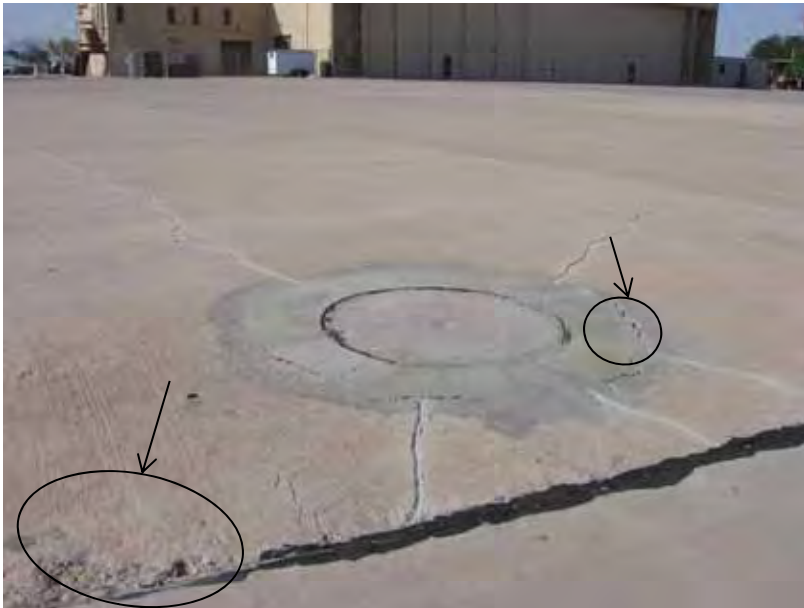
Photograph 11: A previous repair that may warrant additional repairs due to additional cracking and the presence of spalling. Most of the previous repairs within this area are still intact.

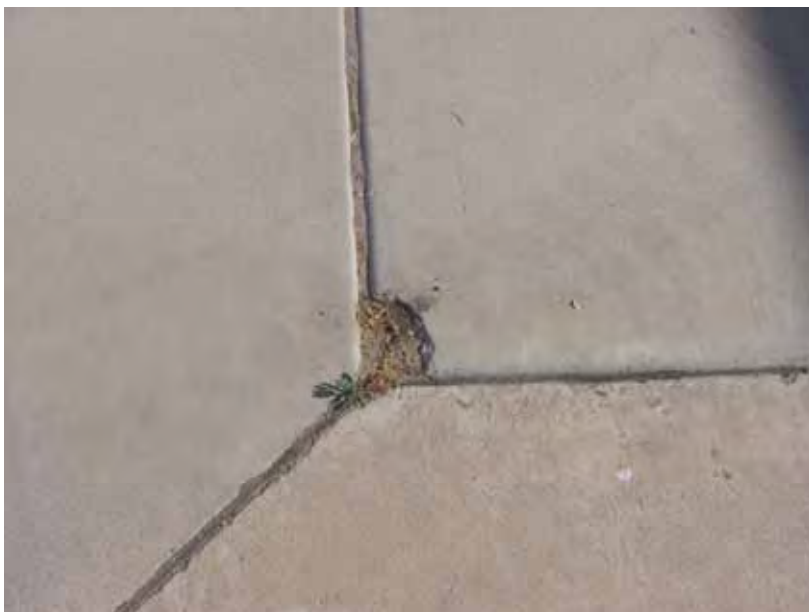
Photograph 12: A location in which a concrete popout has occurred at a corner joint. Repair may be warranted.

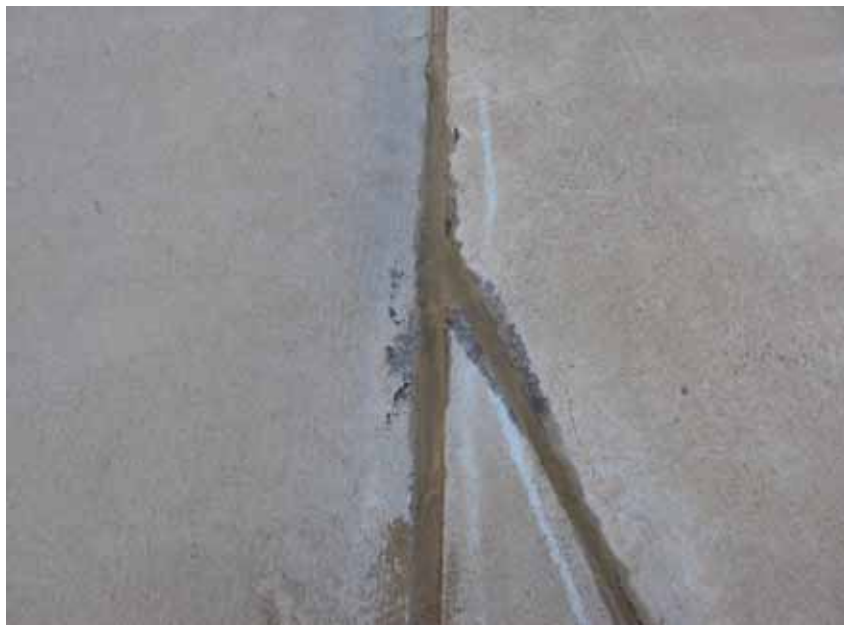
Photograph 13: For 2010 inspection, example of concrete crack that has been repaired and is in good condition.

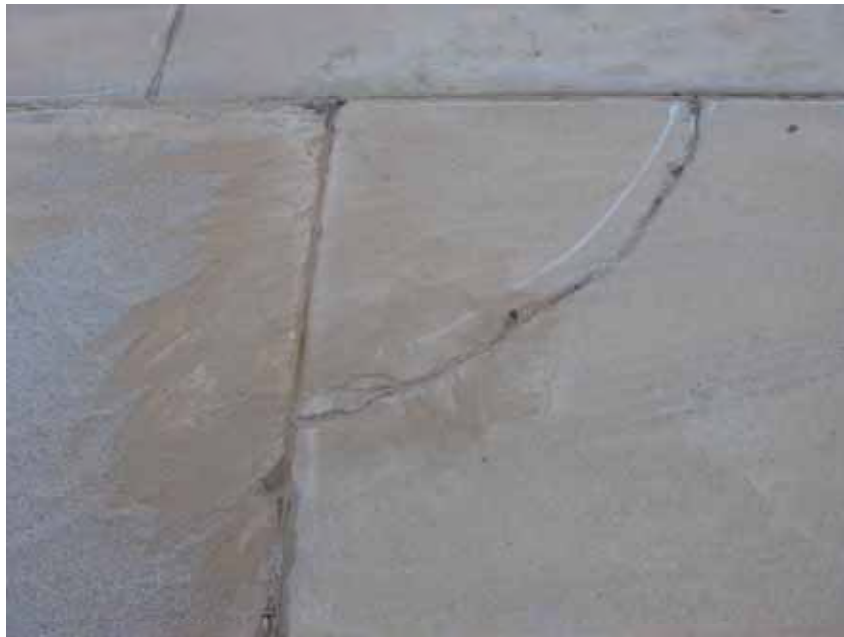
Photograph 14: Concrete crack that may warrant additional repair work; spalling observed adjacent to the crack and some gaping of repair sealant.

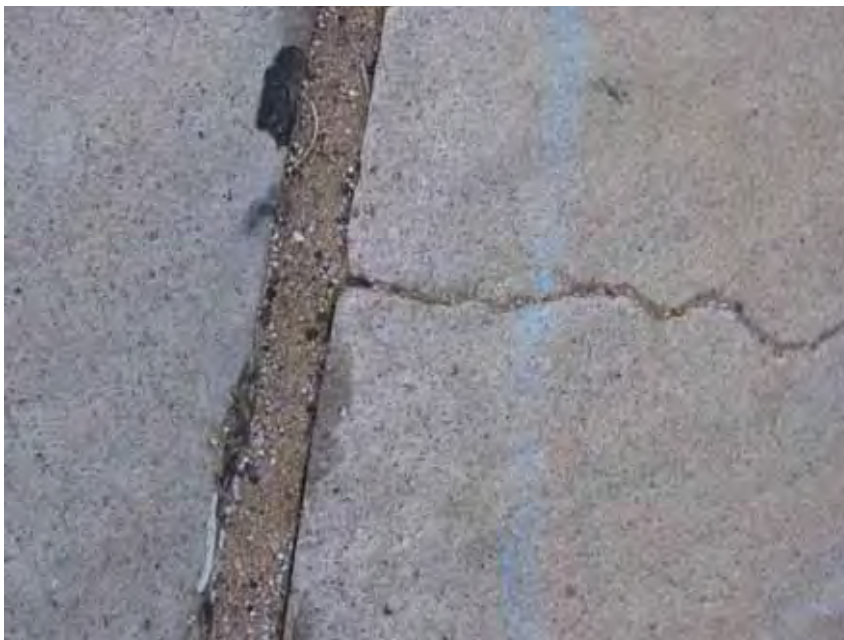
Photograph 15: Hairline concrete fracture intersecting with expansion joint.

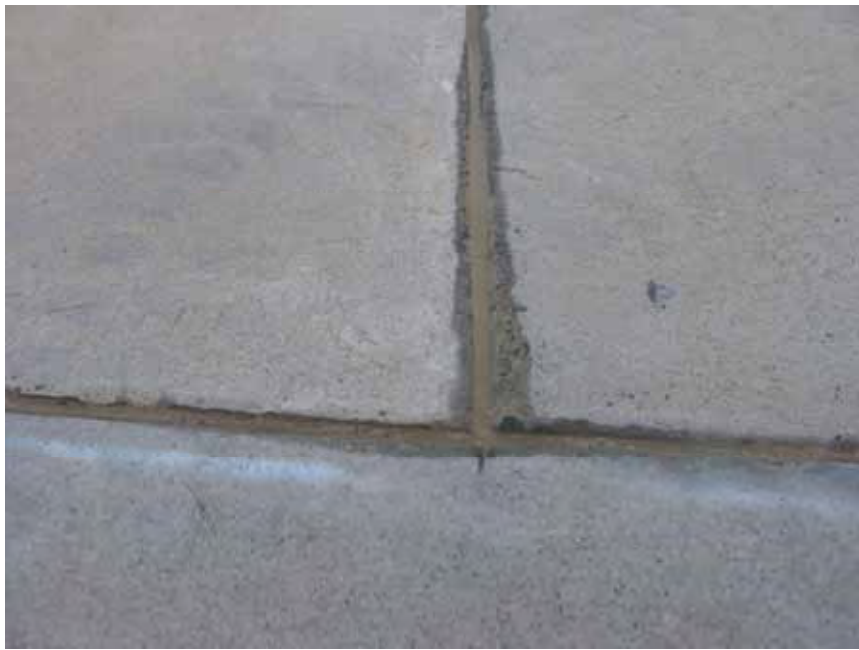
Photograph 16: Example of expansion joint in good condition.

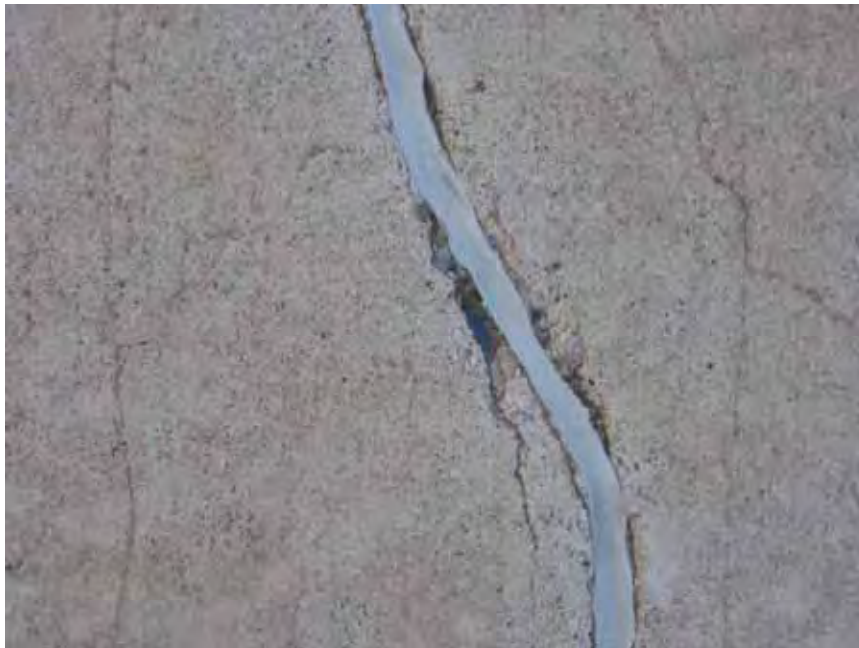
Photograph 17: Example of spalling adjacent to previous crack repair.

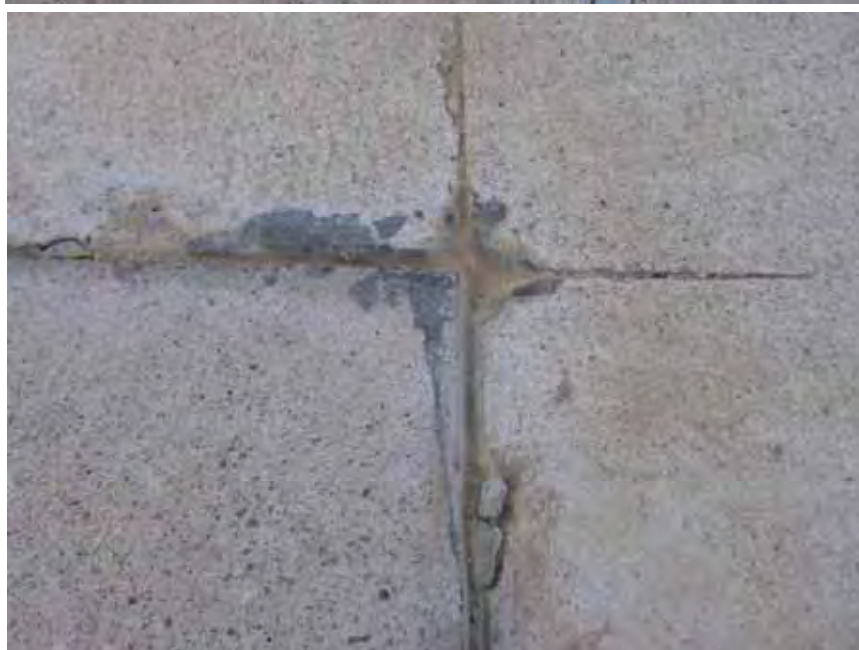
Photograph 18: Repairs on concrete cuts around monitoring well completion; spalling observed.

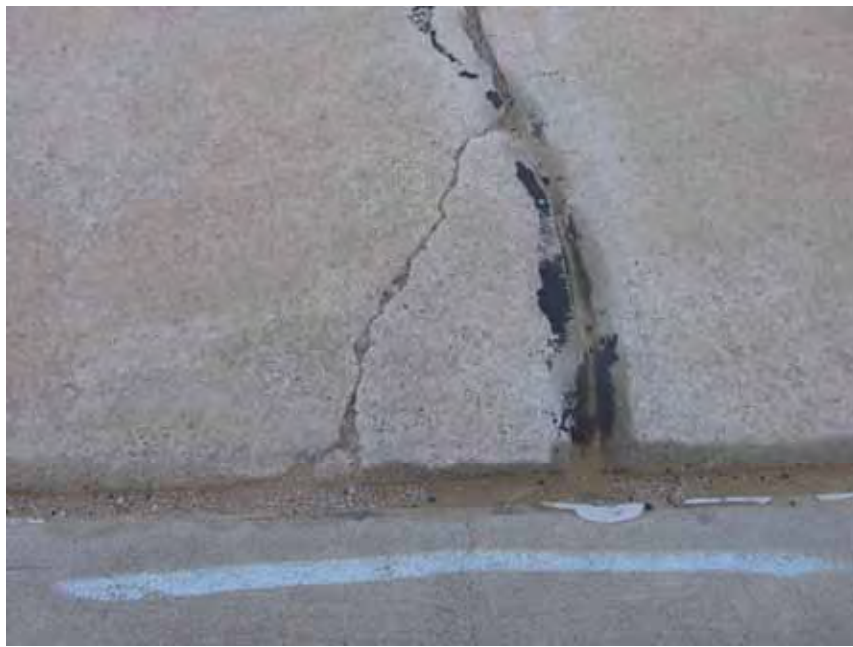
Photograph 19: Earlier repair that may warrant additional work due to presence of spalling and missing repair material.

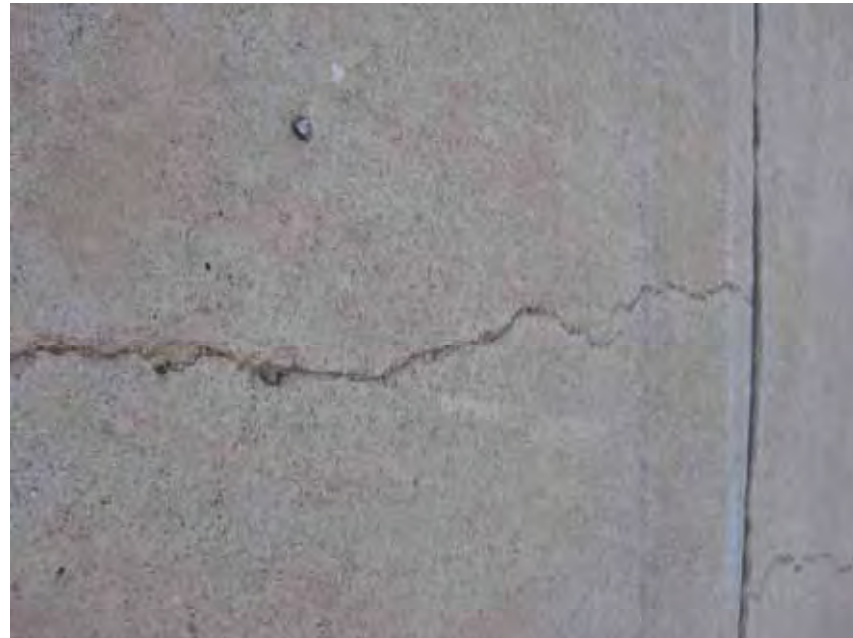
Photograph 20: Concrete crack, intersecting expansion joint, that is several feet long.

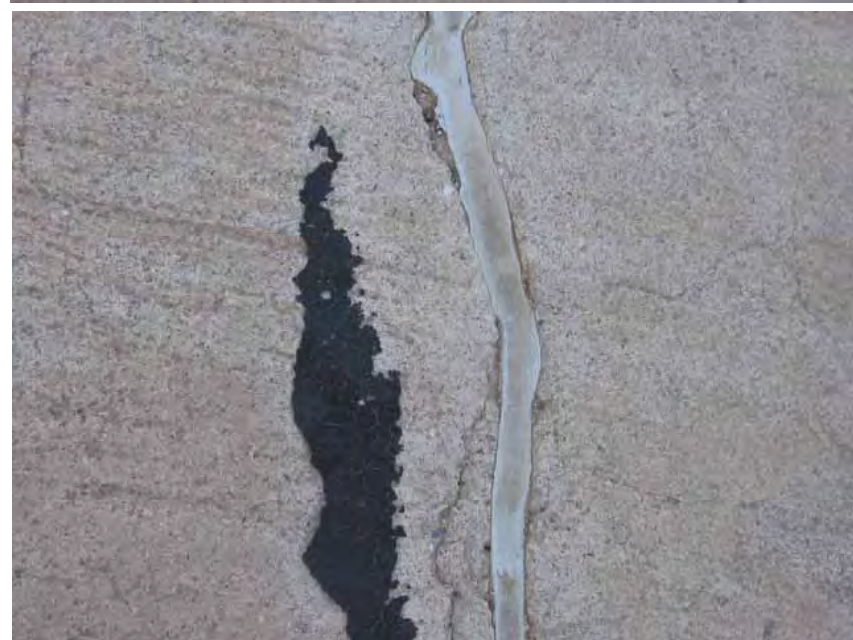
Photograph 21: Example of concrete crack that has been repaired multiple times.

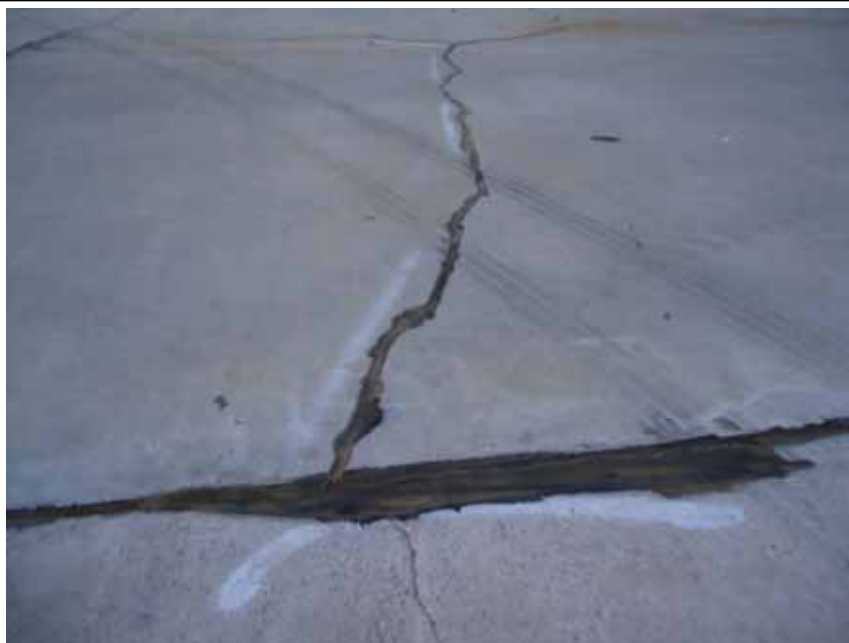
Photograph 22: From 2011 inspection, example of concrete crack that has been repaired (December 2010) and is in good condition.

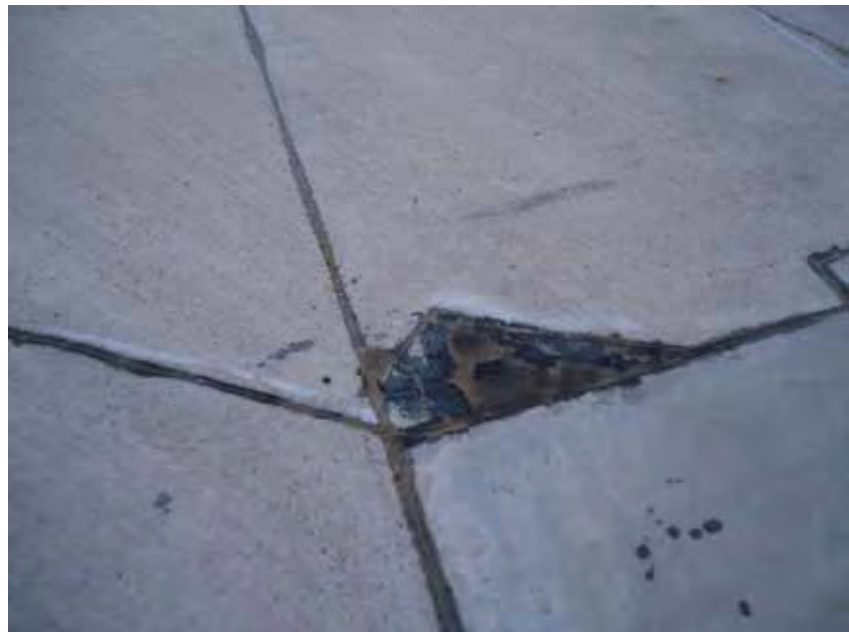
Photograph 23: Repair sealant in corner where spalling had been previously observed.

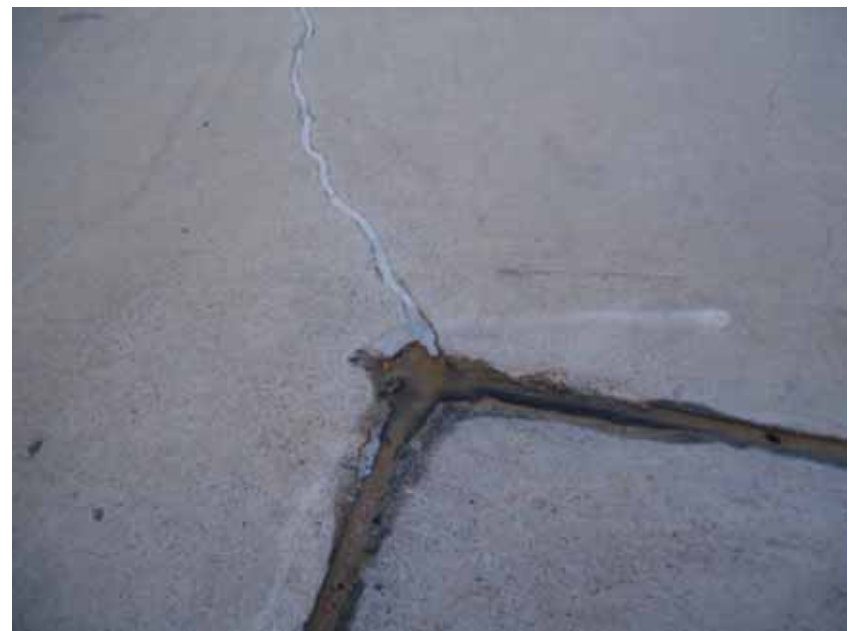
Photograph 24: Example of several generations of repairs.

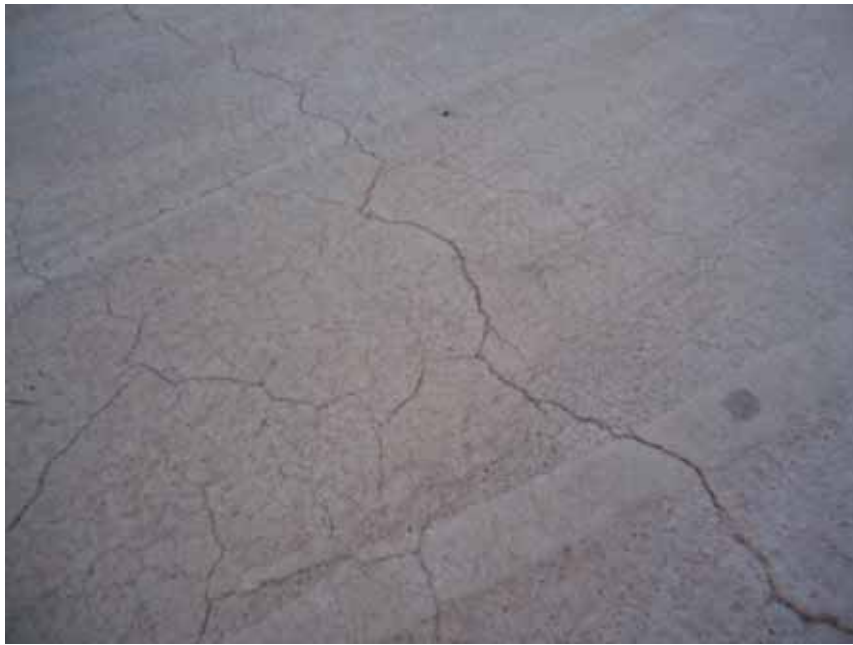
Photograph 25: Hairline cracks that will continue to be monitored.

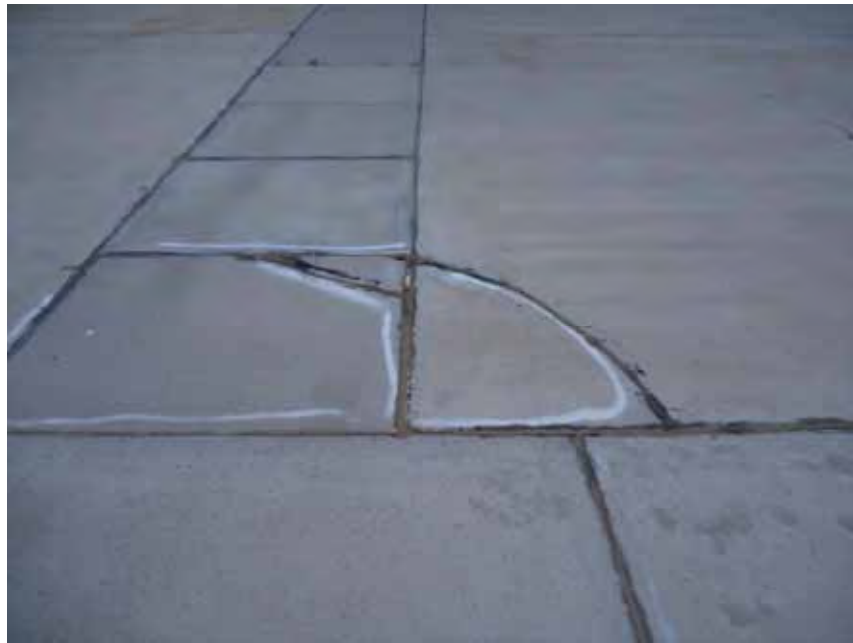
Photograph 26: Newly repaired areas marked by spray paint.

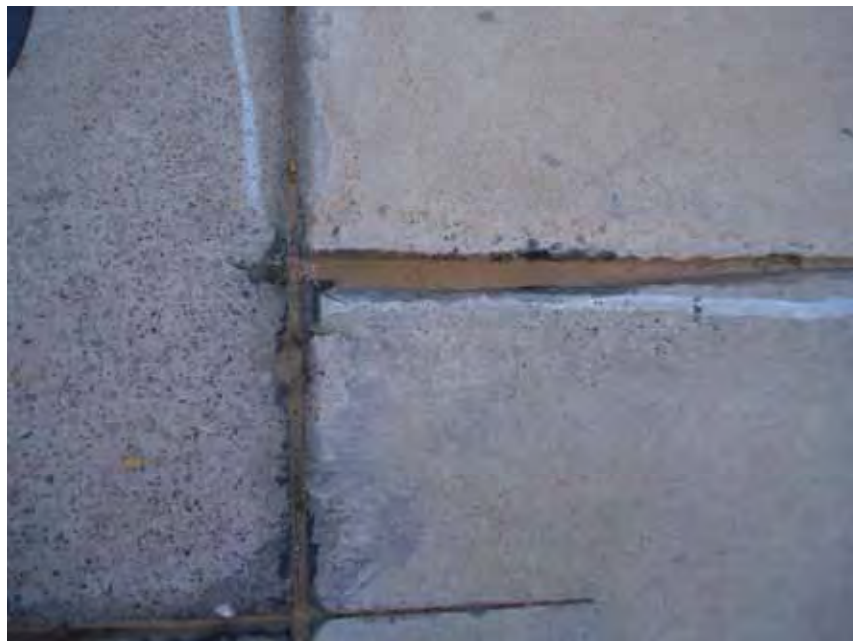
Photograph 27: Example of expansion joint that intersects monitoring well completion. Expansion joint repairs appear to be in good condition.

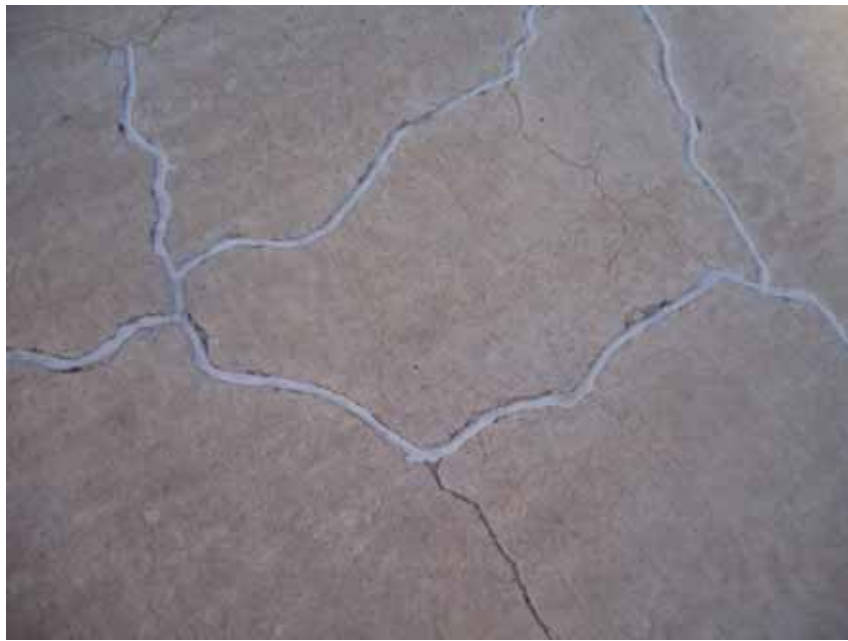
Photograph 28: Hairline crack coming off of previously repaired cracks; area will continue to be monitored.

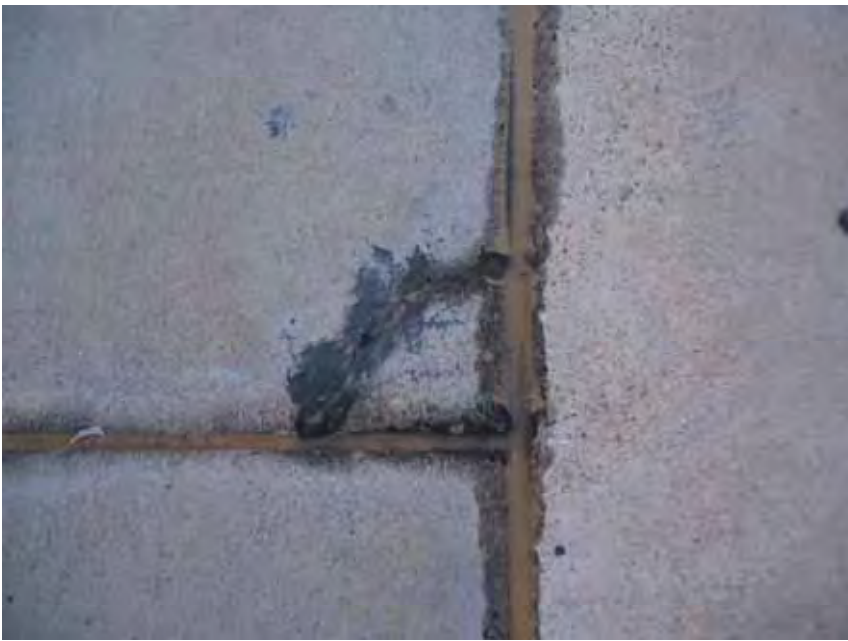
Photograph 29: Example of repaired pop-out on expansion joint corner.

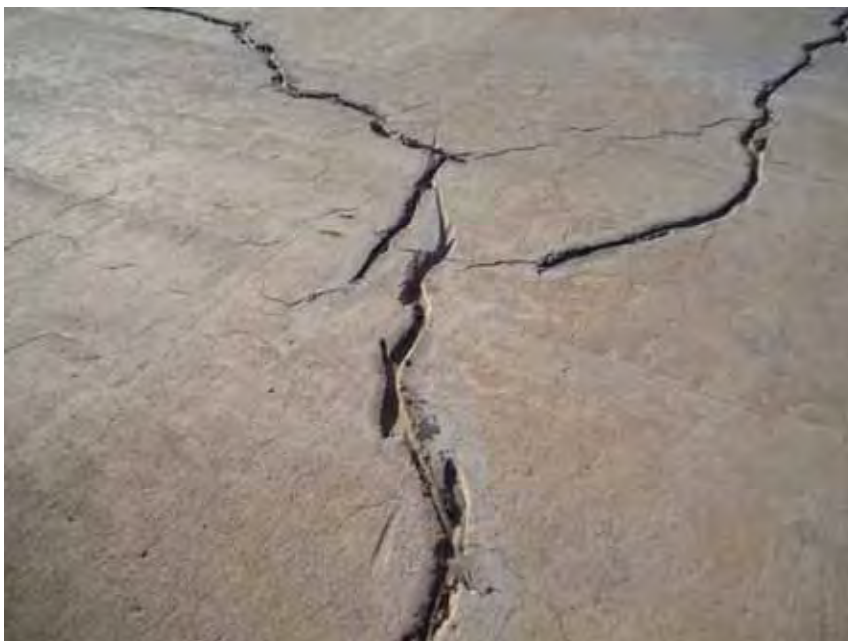
Photograph 30: Example of cracks that have been saw cut and repaired.

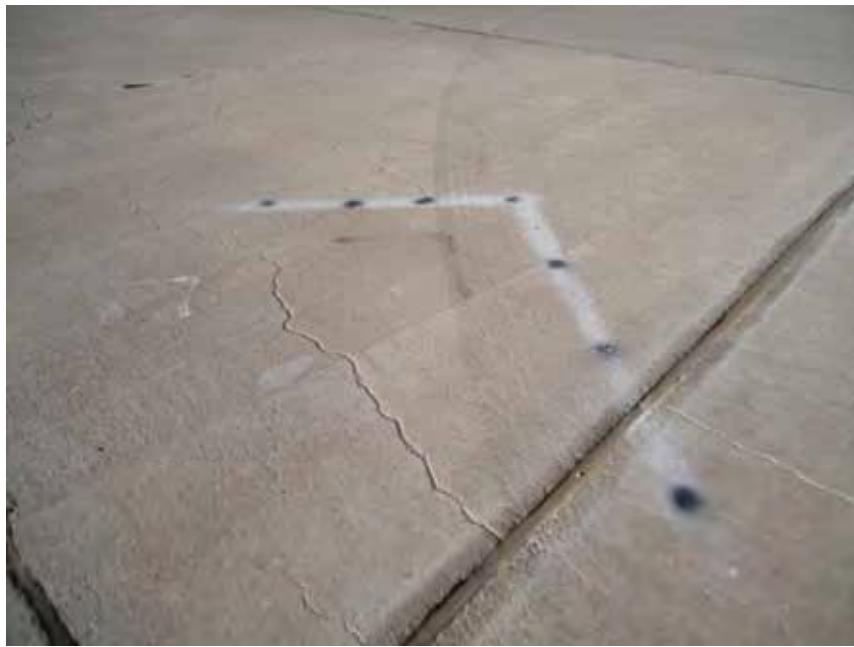
Photograph 31: Example of small crack at corner of concrete cap area.

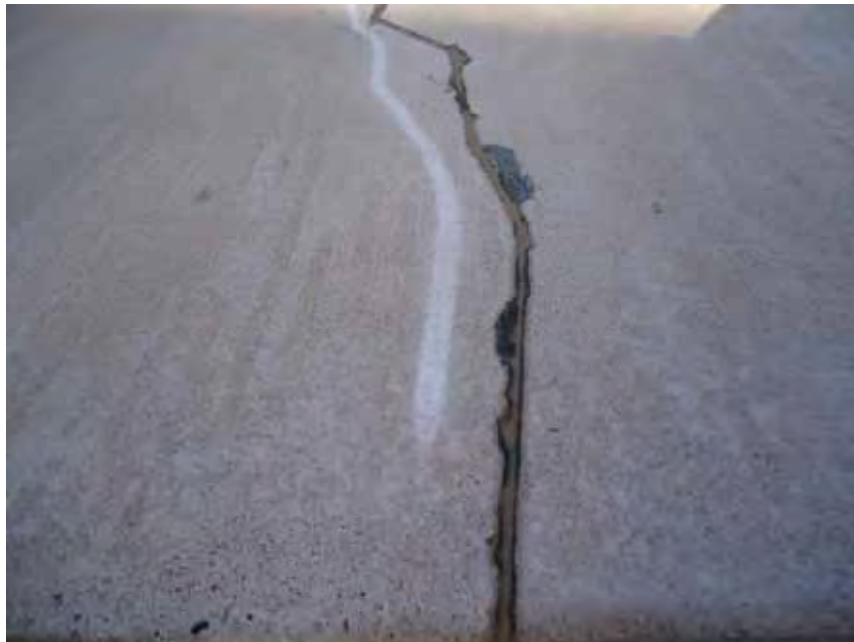
Photograph 32: Example of repaired crack that had limited spalling.

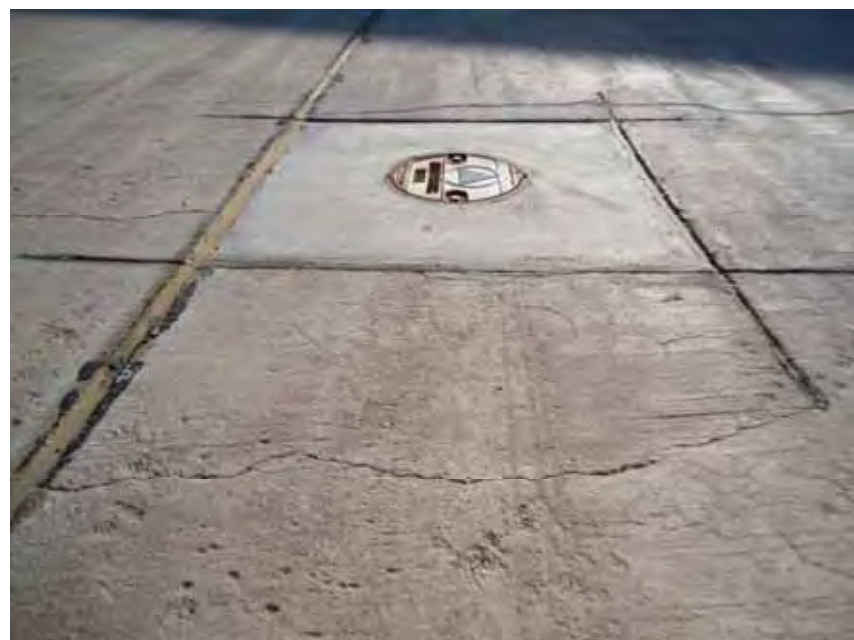
Photograph 33: Crack in concrete near monitoring well that will be monitored during the next cap inspection.
